Manhole Inspection Summary

Manhole # S47MM_014MH

Insp Date: **5/7/08 9:58 AM**

Location Address: **Patterson Park Ave**

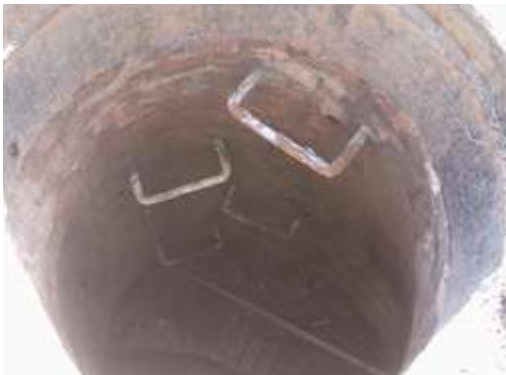
Defect 1

infiltration

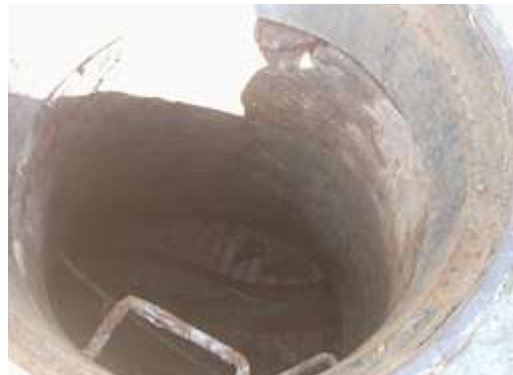
Defect 2

frame leaks

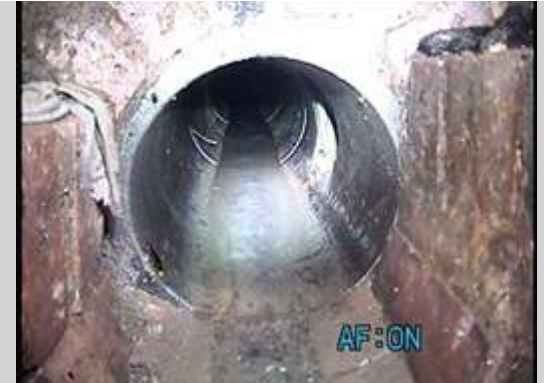
12 O'Clock Outflow

8 in. Circular Gravity Sewer
Pipe Out @ 12 O'Clock

Pipe Height: **8.4** (in.) Rod and Bar (Angled)
Pipe Material: **Clay** ☐ Pipe Lined
Invert Depth: **7.65** (ft.) Flow Characteristics: **None**
Deposits: ☒ None ☐ Mud ☐ Sludge ☐ Debris ☐ Grease
Silt Depth: (in.) Deposits Extent:
Infiltration: **None** Pipe Seal Cond: **Sound**

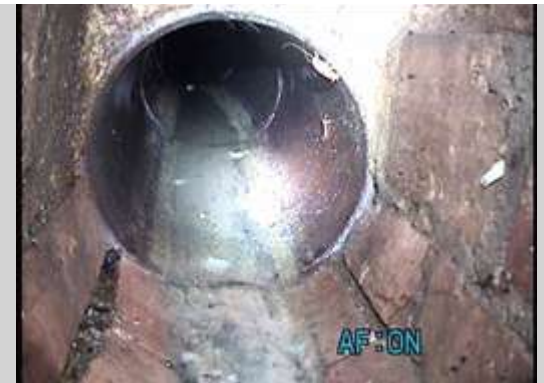
6 O'Clock Inflow

8 in. Circular Gravity Sewer
Pipe In @ 6 O'Clock

Pipe Height: **8.4** (in.) Rod and Bar (Angled)
Pipe Material: **Clay** ☐ Pipe Lined
Invert Depth: **7.85** (ft.) Flow Characteristics: **None**
Deposits: ☒ None ☐ Mud ☐ Sludge ☐ Debris ☐ Grease
Silt Depth: (in.) Deposits Extent:
Infiltration: **None** Pipe Seal Cond: **Sound**
